# FACILITY MASTER PLAN REPORT

*for the* TOWN OF WILMINGTON

APPENDICES

# APPENDIX D : FACILITY CONDITIONS EVALUATIONS

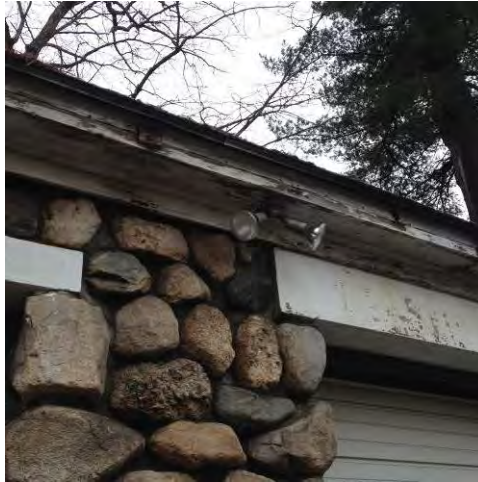
*Front Exterior Lights*

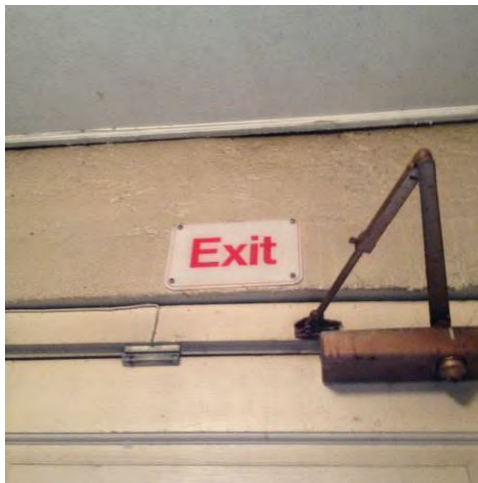
- The emergency lighting consist of one self-contained battery unit with a plug-in cord located in the office. No other emergency lights noted. Exist signs consist of unlit signs.

*Unlit Exit Sign*

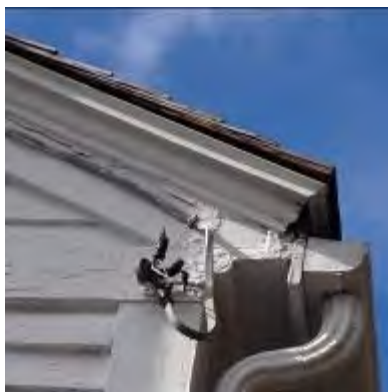
*Sub-feeder to the Carriage House*

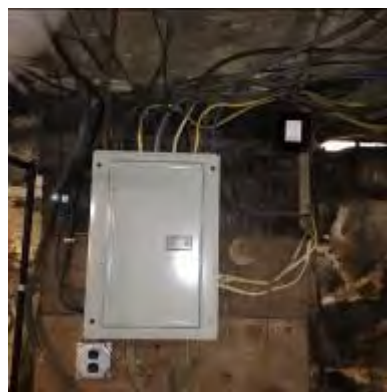
*Load Center in Basement*

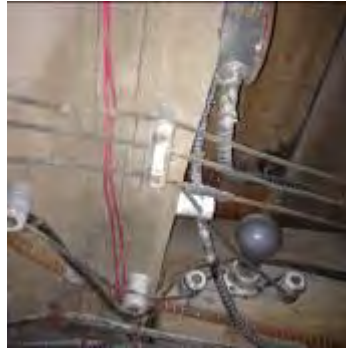
- The wiring method is generally Romex with some MC cable. Knob and tube wiring was noted in the basement. Some Romex is not properly supported. Knob and tube wiring should be replaced or removed if abandoned.

*Knob and Tube Wiring*

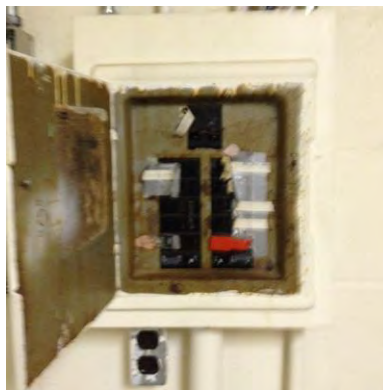
*12 Pole Panel*
