# FACILITY MASTER PLAN REPORT

*for the* TOWN OF WILMINGTON

APPENDICES

# APPENDIX D : FACILITY CONDITIONS EVALUATIONS

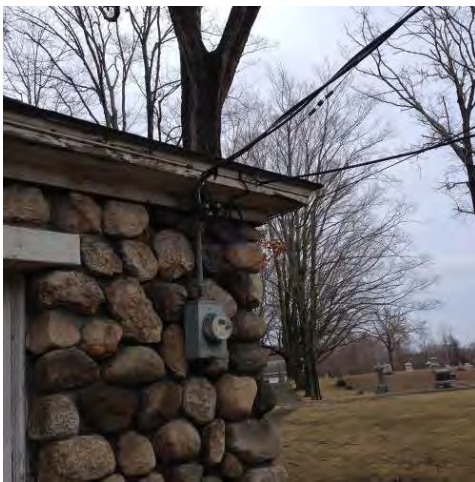
*Utility Meter on Building*

- The electrical service runs overhead between the utility pole and the building mounted meter. The electrical service is rated at 100 amperes, 120/240 volts, 1 phase, 3 wire. A fusible disconnect switch and load center and sub-load center is located high in the garage wall.

Rating: 1

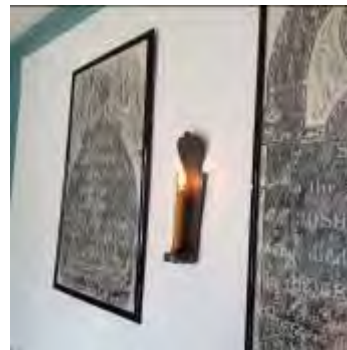
*Wall Sconce*

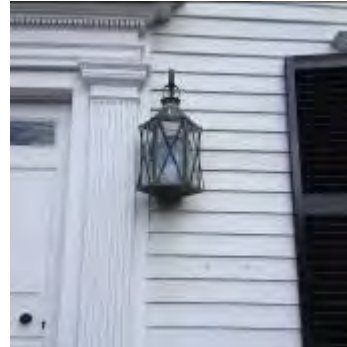
*Wall Lanterns*

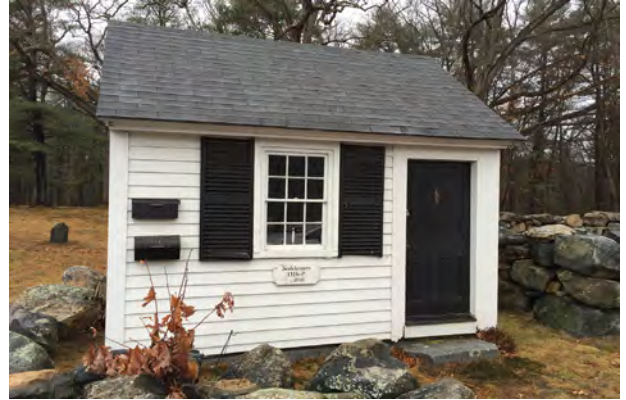
# SCALEKEEPER'S OFFICE

This is a very small, historic wood framed building that shares a site with the Moth House and Town Pound. The facilities are currently being used as an antique showpiece and provides a historic bookend at the northern edge of the Wilmington Center Village Historic District. The Scalekeepers Office was only briefly assessed on the exterior due to the fact that it is an unoccupied building of historic significance.

Exposed granite slab foundation appears to be in good condition. The exterior is painted clapboard siding which appears to be in good condition. The building has asphalt shingle roofing which appears to be in good condition.

The building has electricity running from the Moth House. It is in poor condition and should be replaced. The building has no HVAC or Plumbing systems.

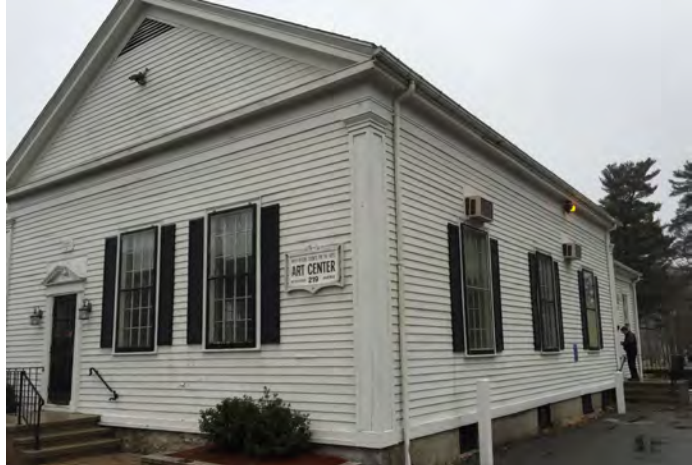
# ART COUNCIL

Painted wood siding and trim are in fair condition. The asphalt shingle roof appears to be in fair to good condition. Exterior windows and doors appear to be original and are in fair condition.

Toilet room electrical outlets are not GFI-protected. Electrical systems were noted to be in poor condition. HVAC includes a relatively new boiler. Plumbing was noted to be in good condition.

The electrical systems for the Art Center are functioning but are in fair to poor condition. The emergency lighting and exit signs need upgrading. The existing cloth insulated wiring in the basement needs to be replaced and removed. Non LED type light fixtures should be replaced. Existing electric service and panel should be replaced.
